## MECHANICAL PROPERTIES OF COMPOSITES MATERIALS SIKACARBODURS512, SIKADUR 30 AND SIKADUR 330

D.A.Hernandez<sup>1</sup> , M.O.Orlandi<sup>1</sup> .

Department of Physical Chemistry, Institute of Chemistry Araraquara<sup>1</sup>, São Paulo State university (UNESP).

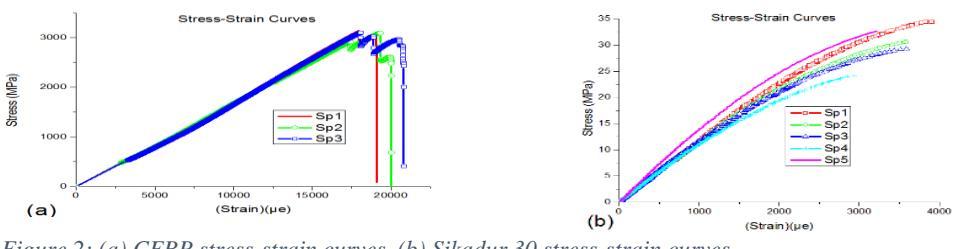
The stress-strain curves obtained from CFRP tension specimens are shown in Figure 2, presenting a linear relationship until failure. Some samples were discarded because they showed a premature failure due to slippage with grips machine and also due to fiber and matrix imperfections, and those manufacturing imperfections on materials were analyzed by microscopy. All the specimens failed suddenly without sign of plastic deformation as shown in Figure 2a. Therefore, Sikacarbodur S512 does not have plastic range, in terms of energy, the total dissipated energy is governed by the stored energy in elastic range, and Sikacarbodur S512 does not have recovery energy due to the lack of plastic range for ductile materials. However it presents high energy dissipation capacity which is a good indicator of performance. The average yielding stress obtained at room temperature was 3,051 MPa, which is higher than the value of 2,800 MPa shown in datasheet of Sikacarbodur S512 and the average young modulus was 165,235 MPa, which is also close to the value 165,000 MPa shown in datasheet of Sikacarbodur S512.

The Stress-Strain curves of sikadur 30 (Figure 2b) show a similar linear segment among samples at the beginning of the slope. However, ultimate tensile stress and ultimate strain are showing a little difference among them. The average young modulus was 12,049 MPa and the average tensile strength at break was 30 MPa. These values are close to the values reported in the material datasheet (11,200 MPa and 31.0 MPa respectively). Note: 1000 ( $\mu$ e) =0.001 absolute strain.

Figure 2: (a) CFRP stress-strain curves. (b) Sikadur 30 stress-strain curves.

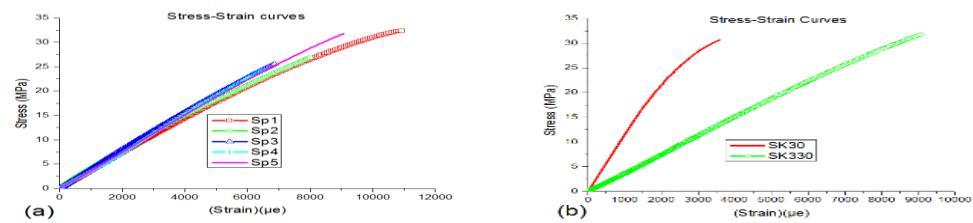
Figure 3 presents the stress-strain curves of sikadur 330 and a linear behavior of the material is observed, some samples failed before reach its ultimate tensile strength due to bubble of air inside the necking region, however the young modulus was not affected as is observed in Figure 3. The average tensile strength obtained was 28 MPa and the average young modulus was 3745 MPa. Both values are lower than the values shown in datasheet, which are 30 MPa and 4500 MPa respectively. The obtained average elongation at break was 0.9%, which is similar than the elongation at break shown in datasheet. Although the obtained values were lower than the values reported in datasheet, they were considered accurate because they were obtained at similar condition that could be found in any other project, i.e., without any special processing.

When comparing stress-strain behavior of sikadur 30 and sikadur 330 it is noticed that, sikadur 330 has better behavior than sikadur 30 since both have almost the same tensile strength at break but sikadur 330 has the biggest elongation at break, more than twice. Moreover, Sikadur 330 has better energy dissipation capacity as can be observed in Figure 3. However, both resins are reported presenting similar values in material datasheets and differences in tensile behavior are not as remarkable as the results found in this study, which shows similar results with those presented by Hassein [1] at 40 °C when elongations at break are considered. Therefore a deeply study is recommended to assure the tensile elongation at break behavior. Both resins present two region, the first one is

Figure 3: (a) Sikadur 330 stress-strain curves (b): Adhesive stress-strain curves relationship

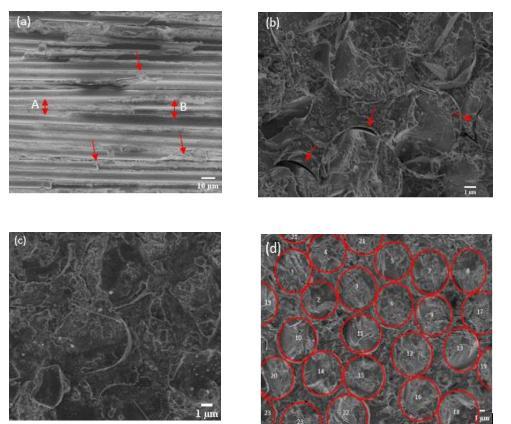
Figure 4 presents a typical SEM micrograph of the longitudinal distribution of fibers in lamina sikacabodur S512. It is observed that the fiber diameter remains constant all over the length of the plate and that the resin layer changes in thickness because depends on fibers and resin arrangements which is a random arrangement depending of pultruded manufacturing process. Some longitudinal fibers discontinuities and misalignments were found (Figure 4), and this may influence some mechanical properties differences on tensile tests.

In the cross-section image of Figure 4, it was observed that fibers are close packaged. The resin is covering the fibers, although some localized cracks and bubbles can be observed. This effect may be attributed either to the processing of material or the SEM sample preparation. However, regarding Figure 4(a) where fiber discontinuities (shown by arrows) and fiber misalignments (shown by arrows A and B) are observed, these defects could not be provoked by SEM samples preparation. Some fibers discontinuities (but not all of them) might be caused while CFRP plate transportation, considering that an external side of the plate is analyzed. However, fiber misalignments in the same figure (shown by arrow A and arrow B) could not be provoked while CFRP plate transportation. Moreover Figure 4(b) indicates the presence of both, some carbon fiber and interfacials cracks (shown by arrows), whereas Figure 4(c) is showing a cross section without cracks in carbon fibers. Therefore, it is noticed that fiber discontinuities and fiber misalignments are neither provoked while SEM samples preparation nor CFRP plate transportation but while CFRP plate manufacturing.

A volume fraction of carbon fiber of 63% and 37% for resin were calculated using Figure 4(d), and an average carbon fiber diameter of 6.66  $\mu$ m was measured using microscopy tool. This means that Sikacarbodur S512 has enough carbon fiber volume to ensure the maximum mechanical properties at lowest cost.

Figure 4: (a) SEM image of longitudinal direction of Sikacarbodur S512 material. (b) SEM cross-section image of Sikacarbodur S512 material. (c) SEM cross-section image of Sikacarbodur S512 material without defects. (d) SEM image of carbon Fiber volume fraction.

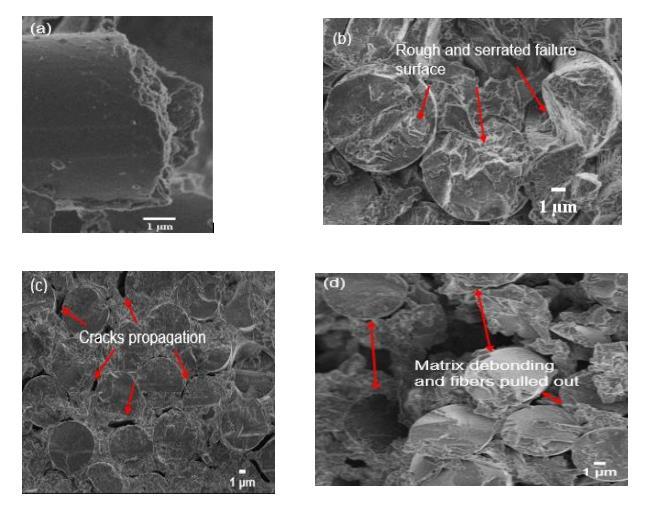
Figure 5 shows Sikacarbodur S512 after test, and the observed failure is typically of a brittle material where failure occurs in a suddenly way. Figure 5(b) presents SEM micrograph analysis showing that the fiber failure surface is nonplanar and irregular with serrated aspect; no necking shape was observed. It is important to notice that no shrinkage in diameter was observed after tests, assuring a brittle fracture of fibers. Figure 5(c) shows the interfacial crack propagation before matrix debonding. The matrix does not transfer in a uniform way all the forces among fibers and some interfacial cracks are avoiding the force to be transferred in a properly way. Figure 5(d) shows matrix debonding which is a process following the interfacial crack propagation. Figure 5 shows rough surfaces after test. Moreover shows that the failure direction is perpendicular to a fiber and load direction. The surface after test is non-planar and irregular; bsides, some carbon fiber failures are consequence of fiber manufacturing defects as misalignments, discontinuities and cracks in fiber surface. As shown in Figure 5 cracks propagate through interfacial zones (contact zone between fiber and resin), affecting the force transferred to carbon fibers then matrix debonding occurs and finally carbon fibers are pulled out, that is because Sikacarbodur S512 plate is not a ductile material and its matrix cannot transfer properly the force among fibers.

Figure 5: (a) SEM image of carbon fiber failure surfaces.(b) SEM image of carbon fiber failed cross sections.(c) SEM image of interfacial crack propagation.(d) SEM image of Matrix debonding.

Sikacarbodur S512 micrograph analysis shows that cracks propagate through interfacial zones (contact zone between fiber and resin), affecting the load transferring to carbon fibers then matrix debonding occurs and finally carbon fibers are pulled out, that is because Sikacarbodur S512 plate is not a ductile material and its matrix cannot transfer properly the force among fibers. Micrograph analysis before and after test of Sikadur 30 and Sikadur 330 shows that for both resin there are the continuous phase and the granular one. Once they are subjected to tensile forces the fine particles are scattered throughout the continuous phase as consequence of micro crack propagation, which explain some observed parts presenting a continuous phase and other parts with different granular phase concentration. Micrograph analysis also shows granular particles bonded among them by covalent alloys (continuous phase of the resin), which once the strength outstripped those alloys, the cast suddenly failed.

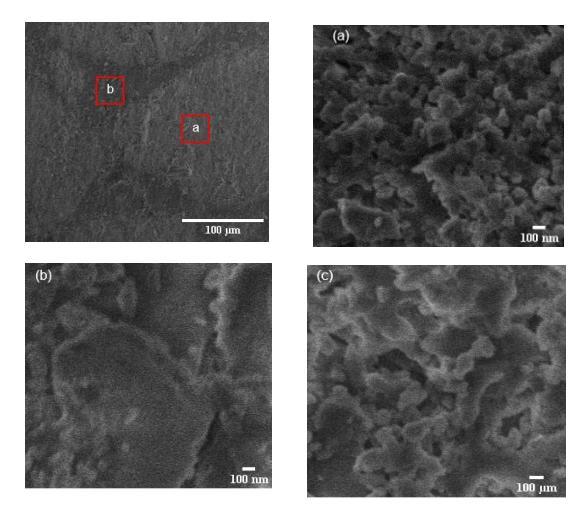
Figure 6 shows a cross section backscattered electron image of sikadur 30, where it is possible to identify two different phases. Figure 6(a) shows a predominated granular phase, while Figure 6(b) presents a predominated continuous phase and Figure 6(c) is the interfacial phase (located in the interception zone between granular phase and continuous phase). Some defects are observed in the cross section; those ones are due to trapped air bubble during the samples preparing procedure and could be avoided if a vacuum environment system is settled during the preparing procedure. However, regarding that during the application of the material in any retrofitting project is not common the used of any vacuum system, those defects were considered as a normal consequence of the procedure followed to prepared the samples, and mechanical properties must be determine taking them into account.

Figure 6: SEM image of Sikadur 30 cross section surface before tensile test.(a)SEM image of granular phase (b) SEM image of continuous phase.(c) SEM image of interfacial phase.

Before tensile test there was a part in the cast cross section governed by fine granular particles (Figure 6(a)) however once the surface became rough and irregular, that part was mixed with the continuous phase of the resin changing its morphology (Figure 7a and b). The continuous phase remains constant but some cracks are observed as consequence of strength concentration.

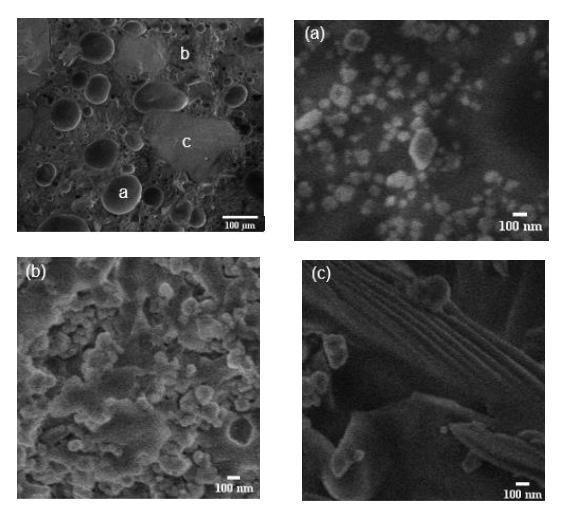
Figure 7 shows SEM images of Sikadur 30 after tensile test, presenting rough, irregular and nonplanar surface, with superficial particles bonded by the continuous phase of the resin. Figure 7(a) shows the granular particles are composed by a continuous phase of the resin coated by fine granular particles. Figure 7(b) shows a mixing between fine granular particles and continuous phase of the resin. Figure 7(c) shows that there is a part of the cross section in the cast where is composed just by the continuous phase of the resin.

*Figure 7: SEM image of Sikadur 30 failure surface. (a) SEM image of granular particles. (b) SEM image of mixing of fine granular particles and continuous phase. (c) SEM image of continuous phase.*

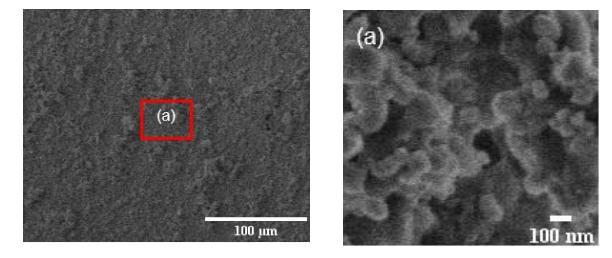
Figure 8 shows that sikadur 330 has a homogenous distribution of phases, its granular phase and its continuous phase are scattered in a uniform way as observed in Figure 8(a) which assure that Sikadur 330 has fine granular particles coating the continuous phase of the resin.

Figure 8: SEM image of Sikadur 330 cross section surface before tensile test. (a) Zoom of red rectangle showing granular particles and continuous phase of the resin.

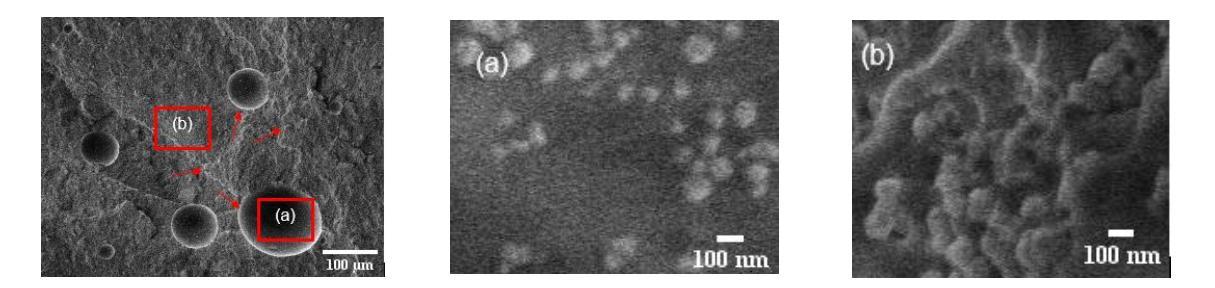
Figure 9 shows some micro cracks propagation in the continuous phase and surrounding the granular phase (shown by arrows). Figure 9(a) shows fine granular particles scattered over the continuous phase of the resin after tensile test, as consequence of the internal movement (heat) of fine particles once they are subjected to a tensile force. Figure 9(b) shows the continuous phase coated by fine granular particles as observed in Figure 8(b) therefore, the sample failed before the tensile force reach this region of the sample.

Figure 9: SEM image of Sikadur 330 cross section surface after tensile test. (a) SEM image of granular phase (b) SEM image of continuous phase.
